# *Bent Creek*

# PROPERTY INSPECTION REPORT

**Concerning:** 1234 Main Street, Fort Worth, TX, 76000  
(Address or Other Identification of Inspected Property)

**By:** George Potter #10086 01/28/2011  
(Name and License Number of Inspector) (Date)

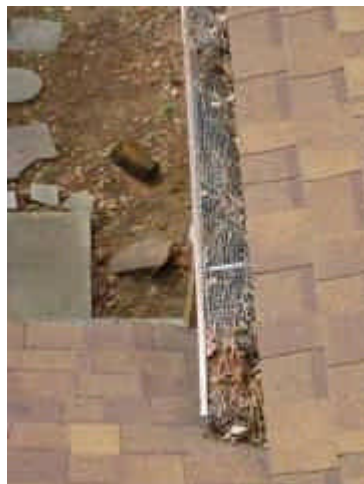
- The gutters require cleaning.

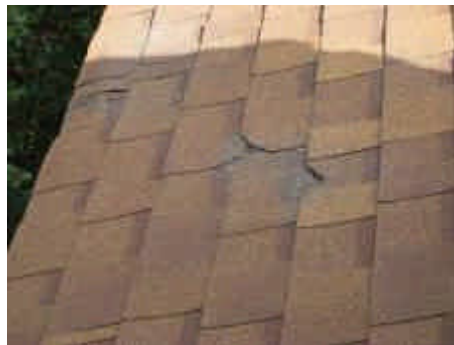
- Roof fasteners (nails and/or staples) observed to be exposed and should be properly sealed at the ridge caps and flashing areas.
- Damaged shingle tabs were observed on the roof structure.

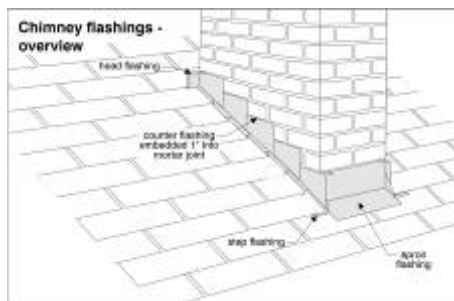
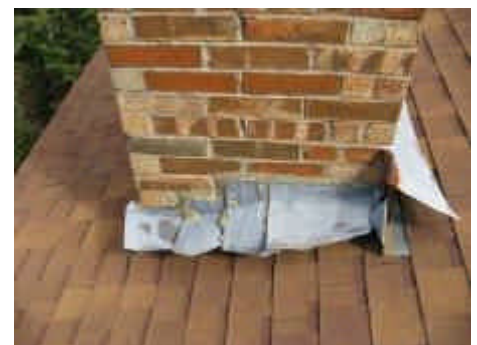
- The flashing needs to be checked reset and/or repaired as necessary.
- The step flashing needs to be checked, reset and/or repaired as necessary at the roof level chimney.

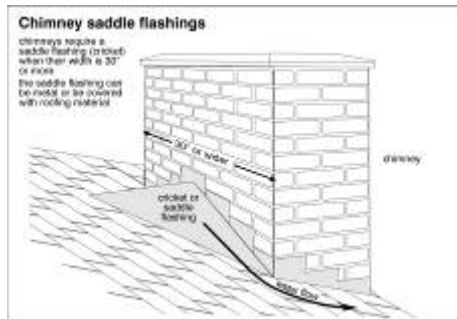
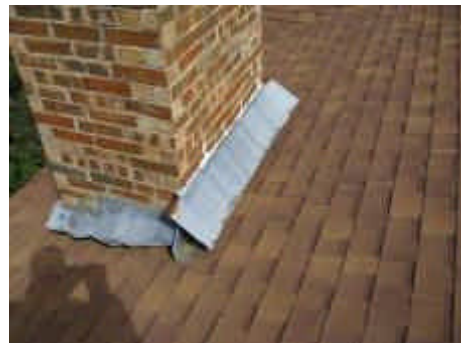
- There is no cricket / saddle in place behind the roof level chimney structure. Under current building standards, there should be a cricket or saddle installed behind the ridge side of

any chimney greater than 30 inches wide. The cricket or saddle can be sheet metal or of the same material as the roofing material.

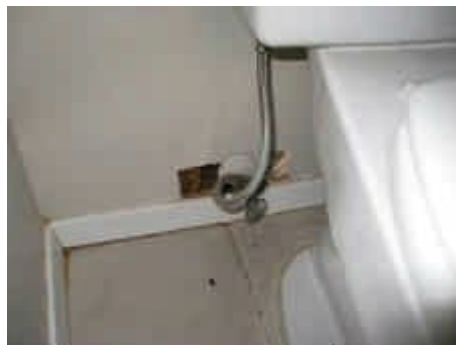
- Areas with water supply lines to toilets are in need of improvement.

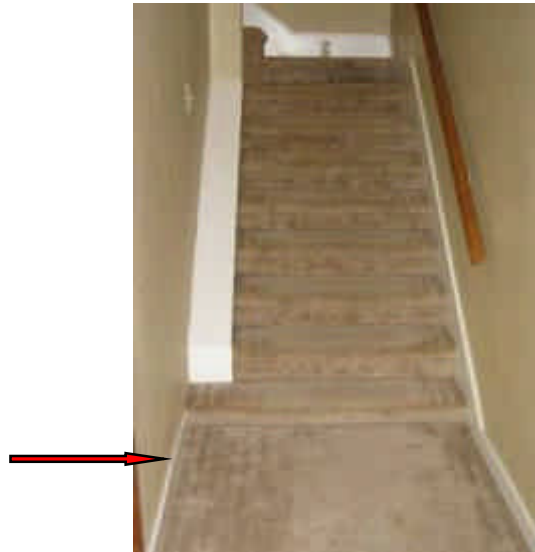
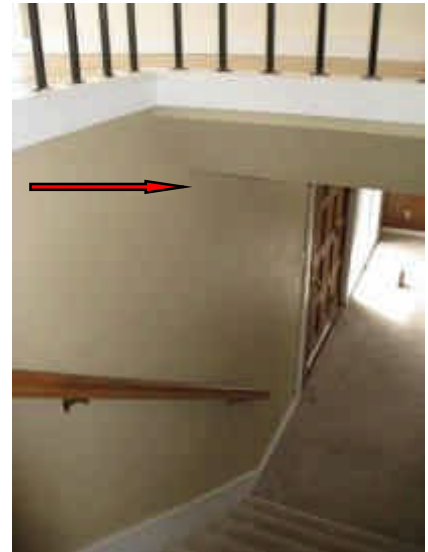
- There does not appear to be enough headroom in the stairwell. Under current building standards the minimum headroom in all parts of the stairway shall not be less than 6 feet 8 inches measured vertically from the slope of the plain adjoining the tread nosing or from the floor surface of the landing or platform.
- Handrail and guardrail balusters are wider than 4 inches.
- The first step is considerably less height than others.

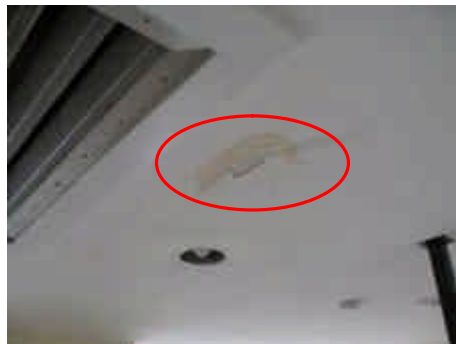
- Water stains observed on the ceilings in the upstairs hall. The cause and remedy should be further evaluated and corrected as necessary.
- Ceiling sheetrock damaged was observed in the same location.

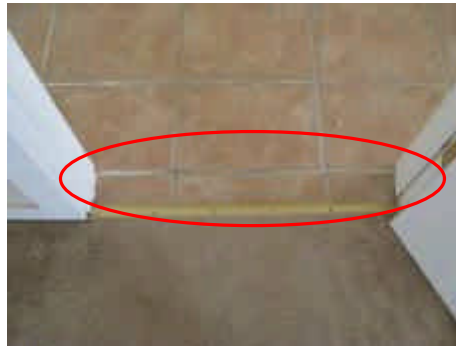
- The upstairs floors are not level in some areas of the house.
- Ceramic tiles are cracked at the joint line leading into the master bedroom, indicating a possible flooring problem.

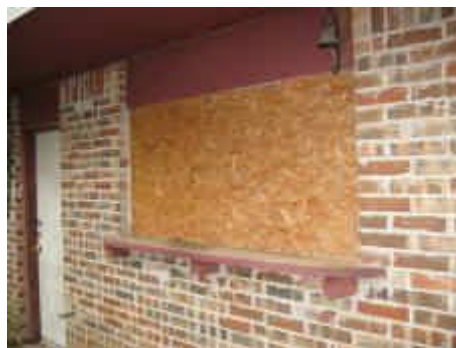
- Window in kitchen area is missing and damaged due to forced entry.

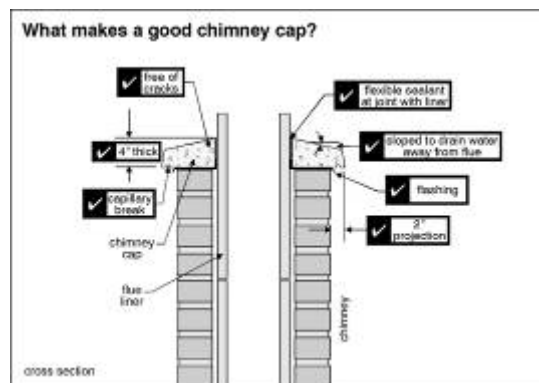
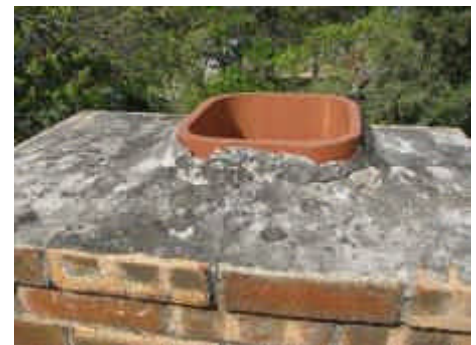
- The roof level chimney mortar cap/crown is in need of improvement.

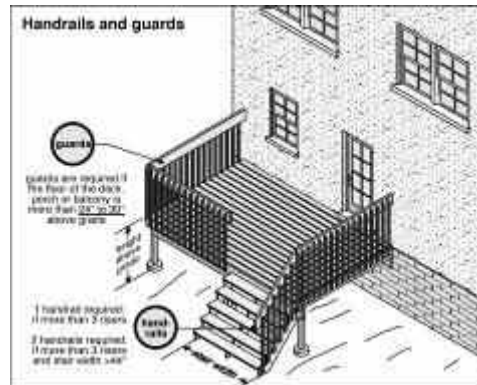
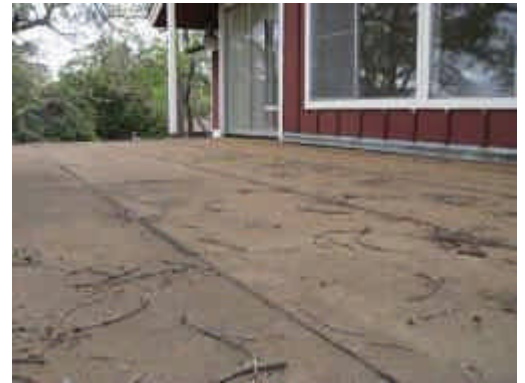
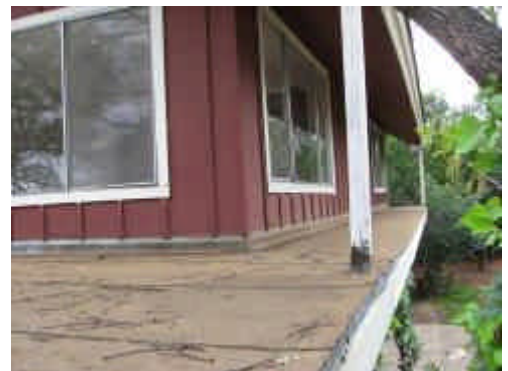
- The balcony at the end of the upstairs hall has not guardrails. Open sides of stairs and balconies with a total rise of more than 30 inches (762mm) above the floor or grade below shall have guardrails not less than 34 inches (864mm) in height measured vertically from the nosing of the treads.

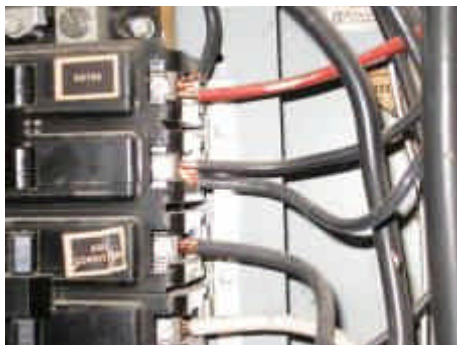
- All blank spaces in the panel box cover plate (dead front) and /or cabinet need fillers.
- One or more of the cover plate screws are missing and need to be replaced.
- Panel box cover plate should be mounted with blunt tip screws and not sharp wood type screws for reasons of safety.
- One or more of the breakers in the panel box were observed to be double lugged (i.e. two wires under one screw). The breakers in place are not listed or labeled for this type of installation and should be corrected as necessary.

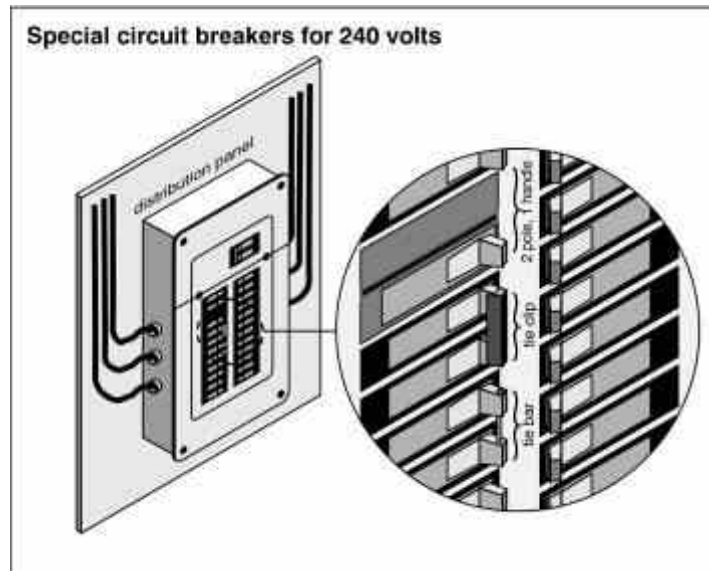
- One or more of the breaker trip-ties are missing. The split overcurrent devices (breakers) servicing 240V appliances should be connected together by trip-ties.

- There was no anti-oxidant gel observed on the aluminum conductor terminations.

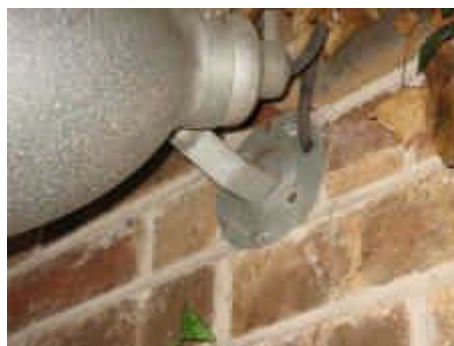
- Improper copper/aluminum connection observed
- There was no anti-oxidant gel observed on the aluminum conductor terminations.
- The sliced wires under the eave/soffit at the security light(s) should be properly enclosed in a weather-tight junction box.

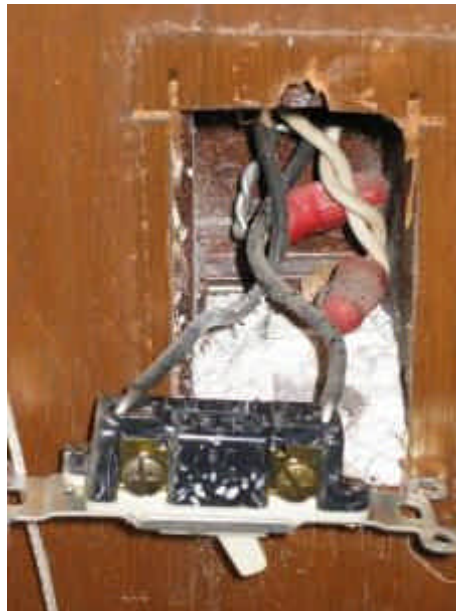
- Not all of the kitchen counter top receptacles appear to be connected to a ground fault circuit interrupter (GFCI) device. Under current electrical standards, all of the kitchen counter top receptacles should have GFCI protection.
- Receptacle(s) observed to have an open ground connection in several locations.
- Receptacle(s) observed to be damaged in bedroom.
- Receptacle(s) appear to have reversed polarity (i.e. it is wired backwards). This receptacle(s) and the circuit should be investigated and improved as necessary. The receptacle(s) in question are located in kitchen.
- Improper copper/aluminum connections observed at receptacles and/or switches.

- There was no anti-oxidant gel observed on the aluminum conductor terminations.

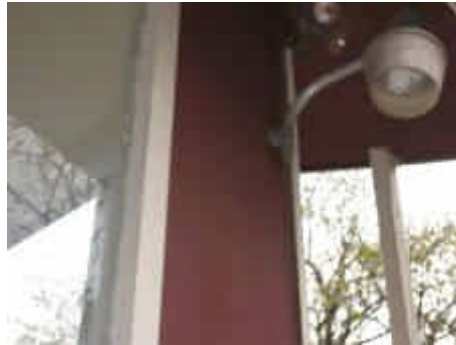
- Several light fixtures were observed to be inoperative.
- Exterior light fixtures and wiring are not in conduit or weatherproof hardware.

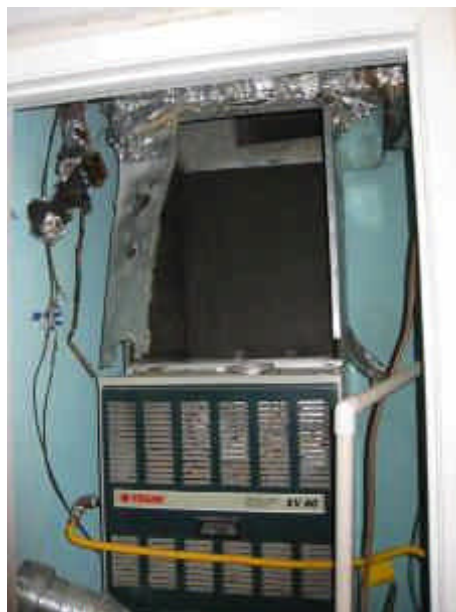
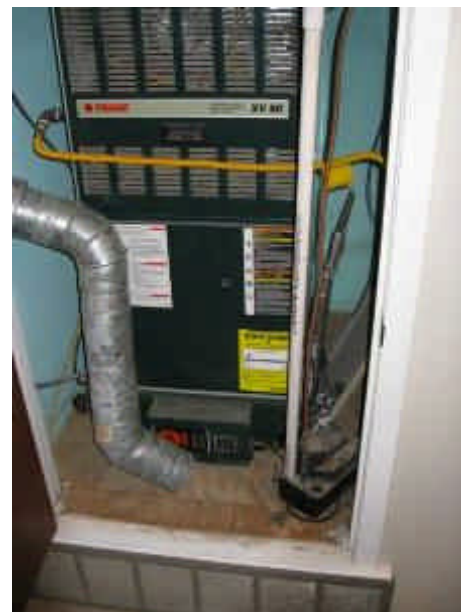
- **HVAC unit(s) is missing components and is not functional, both for the interior and the exterior portions of the system.**

**Note:** When **D (Deficient)** is marked, it is recommended that this item be fully investigated by a Qualified Licensed Heating Technician, prior to closing, to fully evaluate the integrity of the heating equipment.

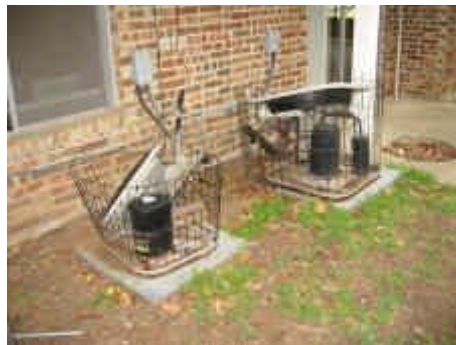
- **HVAC unit(s) is missing components and is not functional, both for the interior and the exterior portions of the system.**

**Note:** When **D (Deficient)** ) is marked, it is recommended that this item be fully investigated by a Qualified Licensed Heating Technician, *prior to closing*, to fully evaluate the integrity of the heating equipment.

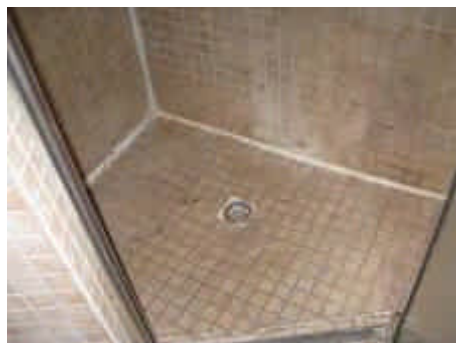
- Appears to have been repaired for leaks around the shower pan and vertical walls.

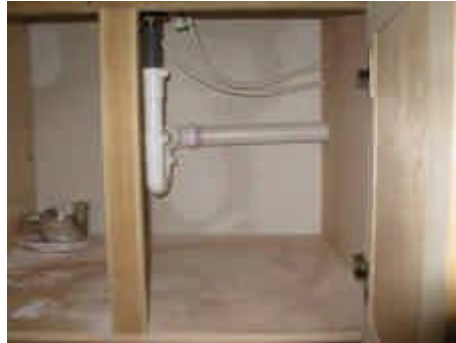
- Drain line in cabinet has a negative slope and should be corrected.

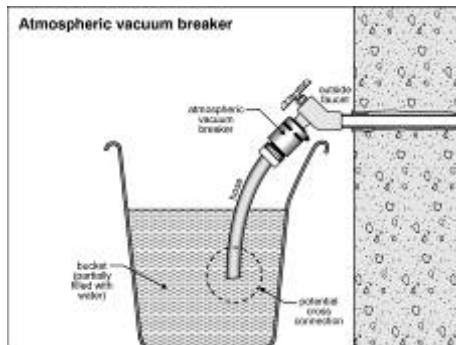
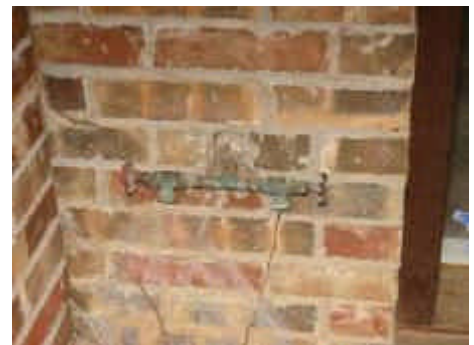
- One or more of the exterior water hose bibs (faucet) do not have a back-flow or anti-siphon device (Vacuum Breakers). **Note:** This is not uncommon to observe with a home of this age.

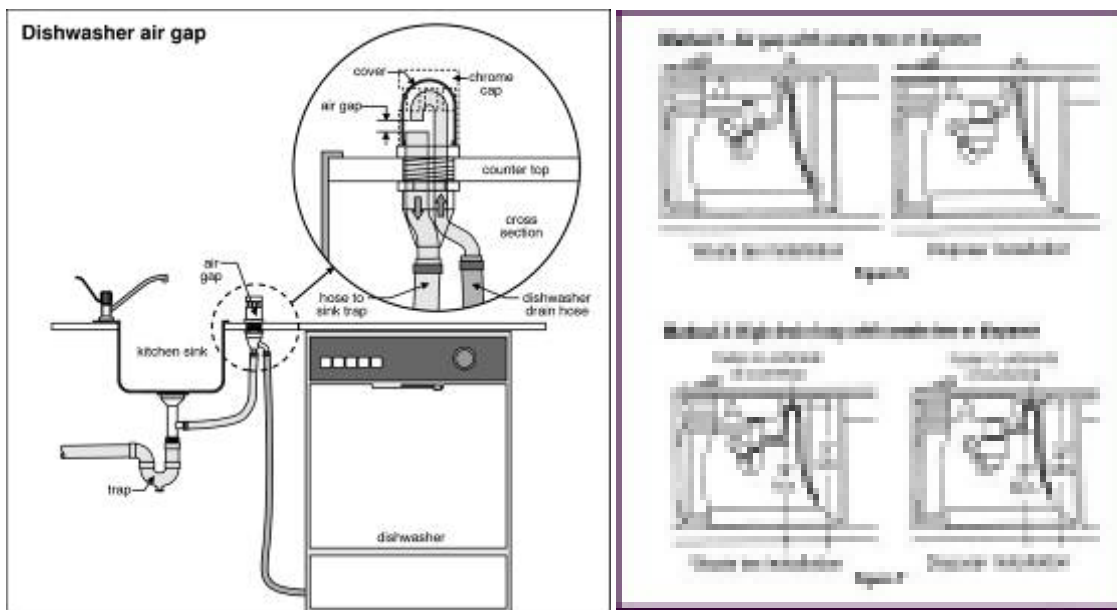
- The dishwasher drain hose is not properly installed to prevent back flow or anti-siphoning. It is recommended that an air gap device or hose loop be installed in the drain line.

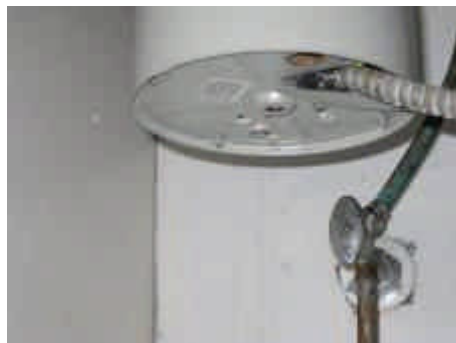
- The electrical wiring to the food waste disposer is not properly secured to the disposer housing. This condition should be corrected for reasons of safety.
