# *Bent Creek*

# PROPERTY INSPECTION REPORT

**Concerning:** 1234 Main Street, Fort Worth, TX, 76000  
(Address or Other Identification of Inspected Property)

**By:** George Potter #10086 01/28/2011  
(Name and License Number of Inspector) (Date)

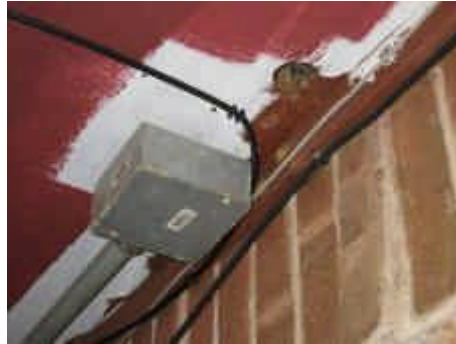
**Fixtures**

- Several light fixtures were observed to be inoperative.
- Exterior light fixtures and wiring are not in conduit or weatherproof hardware.
